Technical Service Bulletin (TSB) - VR1J45GGRJY057489	
D6AW0189Q0 : Version 2 of 18/02/2020	Cancel and replace the document of 13/06/2019
FOR : DS 7 CROSSBACK (X74) AND FRONTDS 7 CROSSBACK (X74)REAR RADAR OBSTACLE SENSOR	
CUSTOMER SYMPTOM :	INFORMATION : POOR VISIBILITY OF THE IMAGE TRANSMITTED BY THE VISUAL MANOEUVRING ASSISTANCE CAMERA AND/OR THE VISUAL REVERSING ASSISTANCE CAMERA 180°
CONDITIONS IN WHICH FAULT APPEARS :	WHILE MANOEUVRING AND REVERSING IN LOW LIGHT CONDITIONS

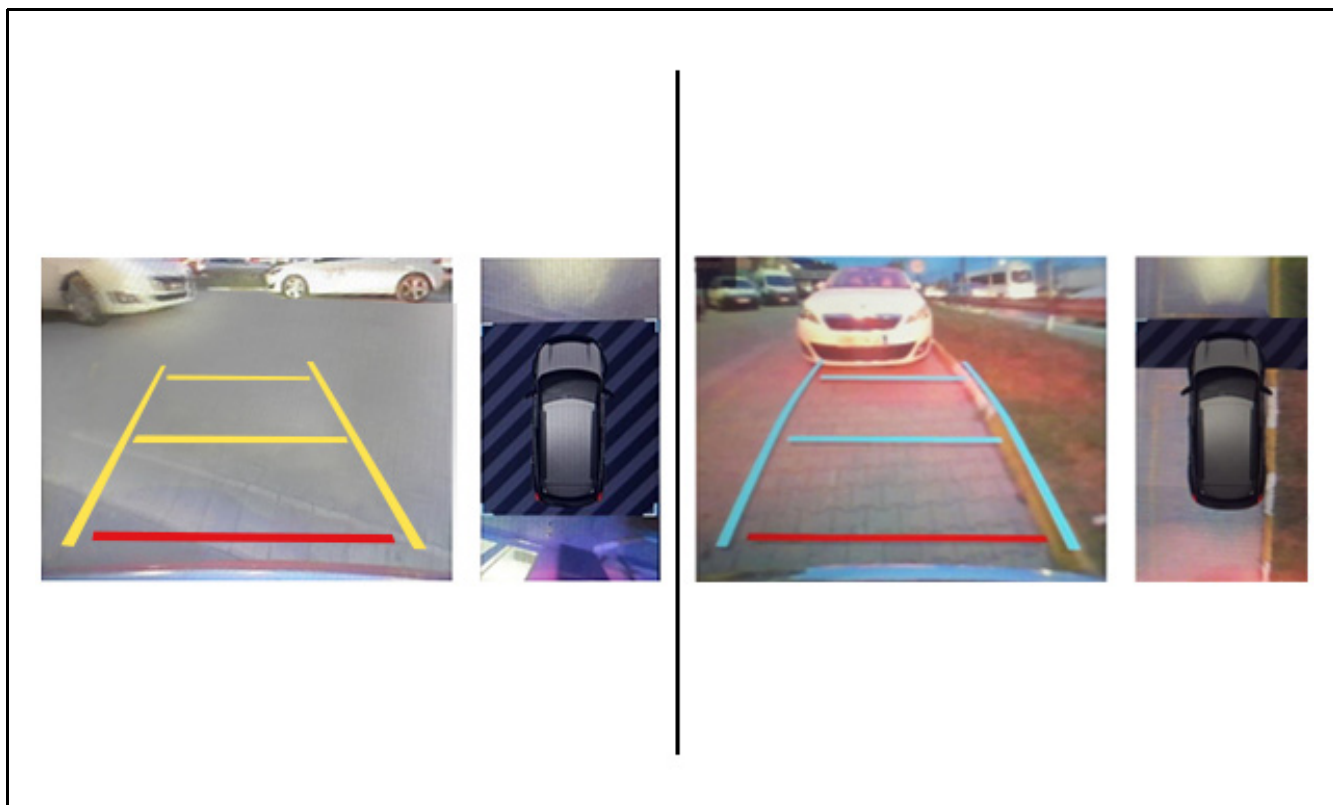
Figure : D6AW05UD

Pixellation and/or degradation of the image definition is possible due to exterior low-visibility.

The illustrations above conform to the expected image definition.

CAUTION : Check that the visual manoeuvring assistance camera and/or the visual reversing assistance camera 180° are clean before confirming the image quality

Explain the phenomenon to the customer.

The operation conforms to specification ; Do not replace parts.

N.B. : The brightness of the multifunction screen may need to be set/adjusted to optimise the image quality
