Technical Service Bulletin (TSB) - VR1J45GGRJY057489	
D6AW01AWQ0 : Version 0 of 20/11/2018	
FOR : DS 7 CROSSBACK (X74)	
CUSTOMER SYMPTOM :	THE MESSAGE FUNCTION (DRIVER'S SEAT) DOES NOT WORK
CONDITIONS IN WHICH FAULT APPEARS :	WHEN THERE IS AN OPERATION REQUEST FROM THE DRIVER

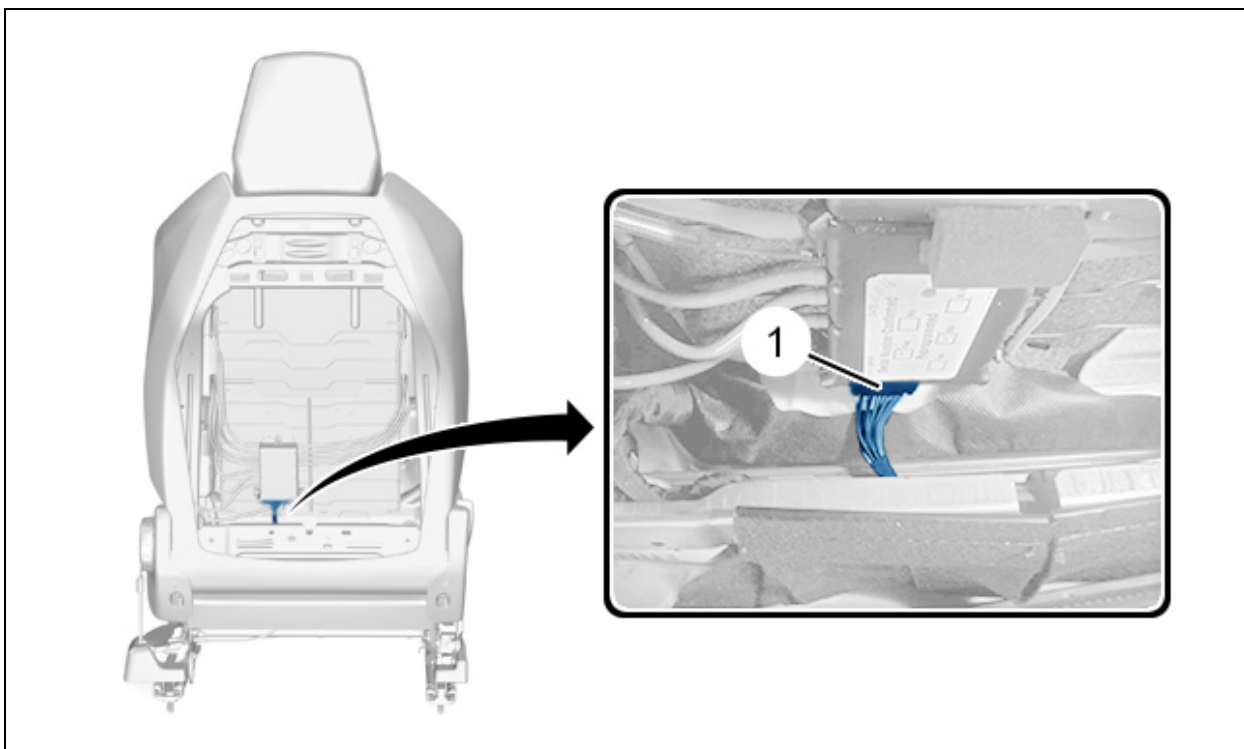
Figure : D6AW083D

Poor connection of the connector on the driver's seat pneumatic functions ECU.

Check the connection of the connector (1) :

- If connector (1) is wrongly connected : Carry out repair
- If the connector (1) is properly connected : Do not apply this document ; Carry out in-depth fault finding

Connect the connector (1).

Refit the rear shell of the front seat.
