Technical Service Bulletin (TSB) - VR1J45GGRJY057489	
D6AW01DKQ0 : Version 5 of 17/03/2020	Cancel and replace the document of 14/02/2020
FOR : DS 7 CROSSBACK (X74)	
CUSTOMER SYMPTOM :	PRESENCE OF MISTING OR WATER DROPLETS, OR WATER INGRESS INTO THE HEADLAMPS AND/OR THE REAR LAMPS
CONDITIONS IN WHICH FAULT APPEARS :	IN SPECIFIC WEATHER CONDITIONS (LOW TEMPERATURE, HUMIDITY), IN HEAVY RAIN, AFTER A PRESSURE WASH

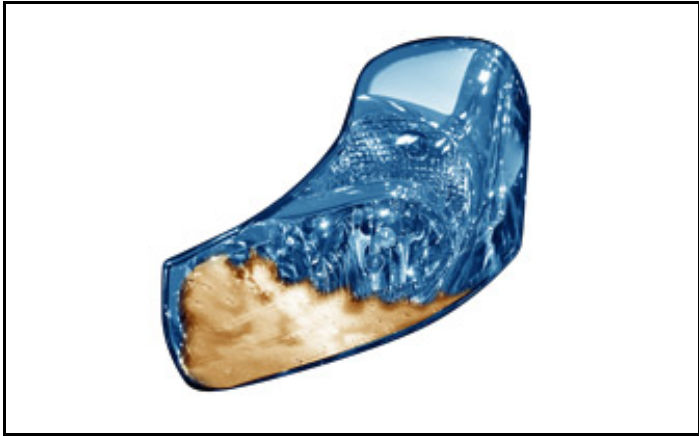
<p>Figure : D6AW0A5T</p>	If there is misting	Carry out repair 1

Do not replace parts.

Explain the issue of natural condensation when turning off the lamps to the customer :

- The headlamp/rear lamp bulbs produce variations in the internal temperature . The headlamps and rear lamps are not sealed to allow the air to circulate . Ventilation is necessary to balance the internal and external air pressure
- In specific weather conditions (low temperature, humidity, rainfall) or after the vehicle is washed, the incoming moisture-laden outside air can condense against the inside face of the component
- The misting diminishes over time (Issue intensified by lamp operation)
- This condensation issue has no adverse effect on the lighting performance and does not give rise to any electrical risk or corrosion
- The internal faces of the component are transparent and are textureless . The issue of natural condensation is more visible than before

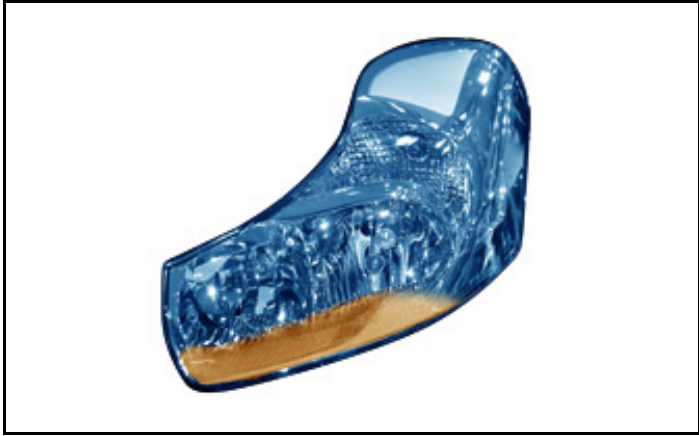
<p>Figure : D6AW0A6T</p>	If there are very localised water droplets	Carry out repair 1
	If there are water droplets over a large surface area	Carry out repair 2

Check the covers, sockets, bulb holders and seals of the headlamps and/or rear lamps :

- If there are anomalies and/or if the fitting is incorrect : Rectify
- If there are no anomalies : Continue the repair

Replace :

- The faulty headlamp(s)
- The faulty front lamp(s)
- The faulty rear lamp(s)

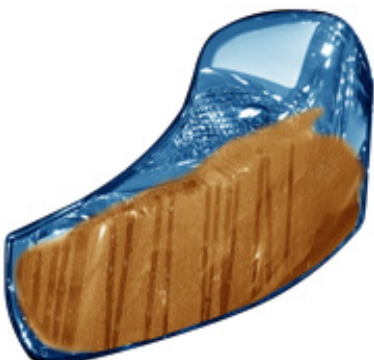
<p>If there are water droplets over a large surface area with water run-off or water marks</p>	<p>Carry out repair 2</p>
<p>Figure : D6AW0A8T</p>

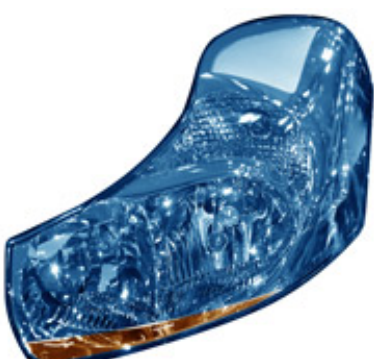
<p>If there is stagnant water</p>	<p>Carry out repair 2</p>
<p>Figure : D6AW0A9T</p>

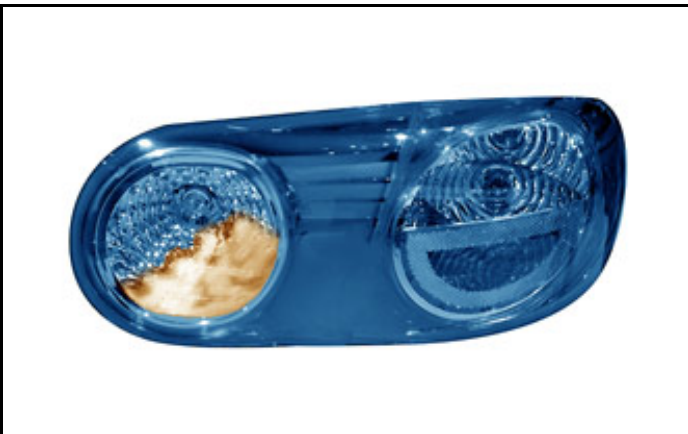
Illustration	Observation	Repair to be performed
	<p>If there is misting</p>	<p>Carry out</p>

<p>Figure : D6AW0AAT</p>		<p>repair 1</p>

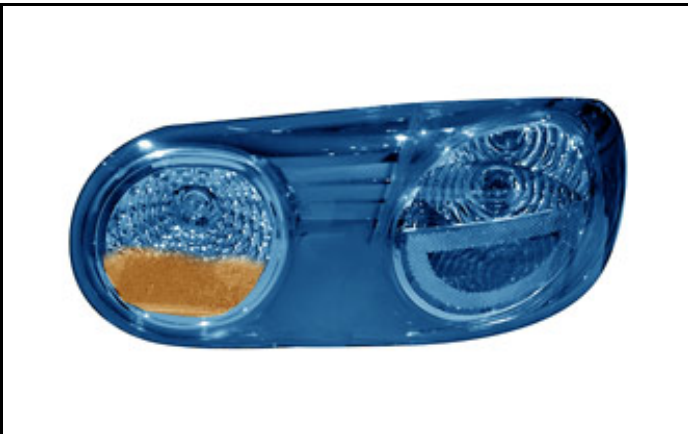
<p>Figure : D6AW0ABT</p>	<p>If there are very localised water droplets</p>	<p>Carry out repair 1</p>

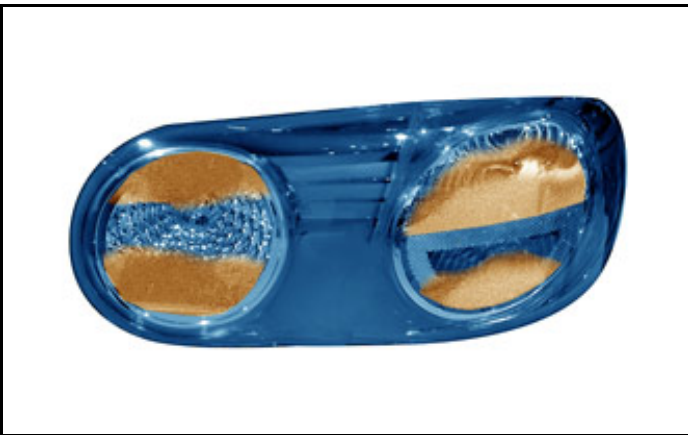
<p>Figure : D6AW0ACT</p>	<p>If there are water droplets over a large surface area</p>	<p>Carry out repair 2</p>
	<p>If there are water droplets over a large surface area with water run-off or water marks</p>	<p>Carry out repair 2</p>

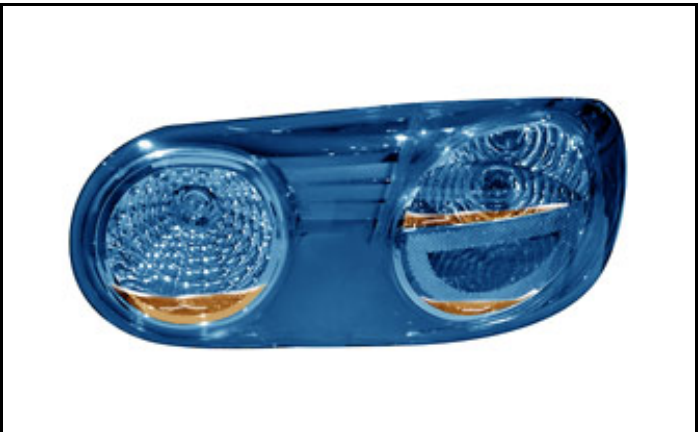
<p>Figure : D6AW0AET</p>	If there is stagnant water	Carry out repair 2
