Technical Service Bulletin (TSB) - VR1J45GGRJY057489	
B1JW011LQ0 : Version 0 of 13/03/2019	
FOR : DS 7 CROSSBACK (X74) UNTIL RPO 15443	
CUSTOMER SYMPTOM :	CORROSION OF THE EXHAUST OUTLETS
CONDITIONS IN WHICH FAULT APPEARS :	PERMANENT

1. ORIGIN

Corrosion of the exhaust outlet heat protectors.

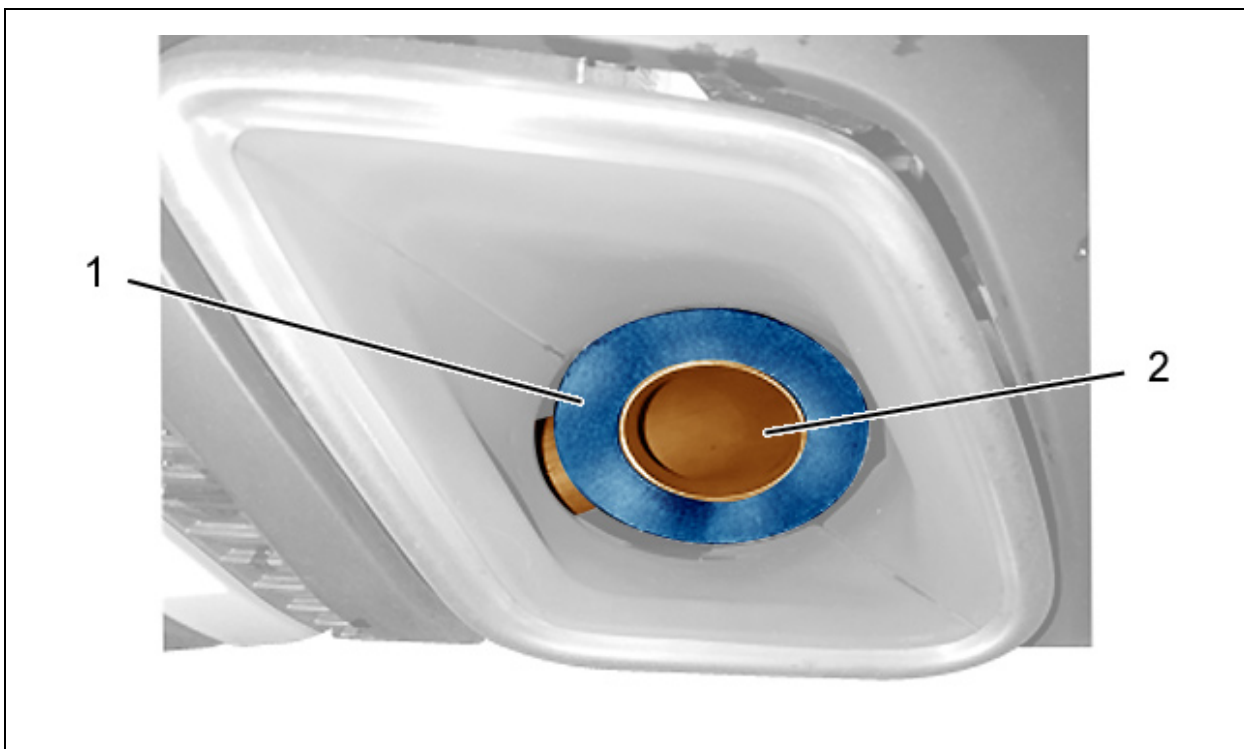
Figure : B1JW00PD

Check for corrosion on the exhaust outlet (2) heat protectors (1) :

- If there is corrosion : Carry out repair
- If there is no corrosion : Do not apply this document
